Award Number: DAMD17-00-C-0031

TITLE: Modeling for Military Operational Medicine Scientific and Technical Objectives

CONTRACTING ORGANIZATION: Jaycor  
San Diego, CA 92121

TYPE OF REPORT: Annual

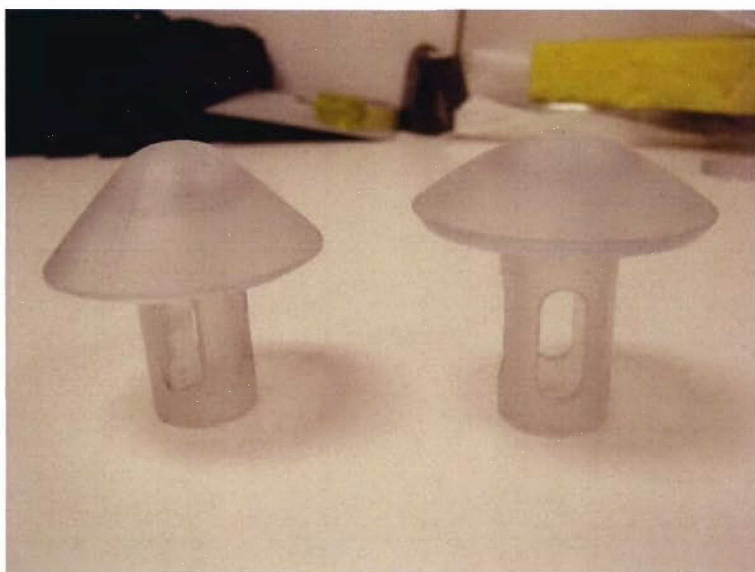
**Impactor clay tests** were conducted using a soft armor impactor and a hard armor impactor, as shown in Figure 2 below. These impactors have different diameter, shape and mass and simulate the behind soft and hard body armor impacts, respectively, at given speeds. Before each test, the clay was heated, using two heating pads and a reflective shell to contain the heat within the clay. The average temperature, taken along four equally spaced depths at nine equally spaced locations on the clay surface, was 93°F. During the tests, the impactors were driven by a piston that was launched by high pressure helium gas. The pressures in the tests varied from 100-800psi. These impactors free-flew after the launching rod was pushed to the end of its length, culminating in the collision with the clay block. The results from the clay tests performed using the impactors are given in Table 1.

Figure 2. SBA Impactor (left) and HBA Impactor (right)

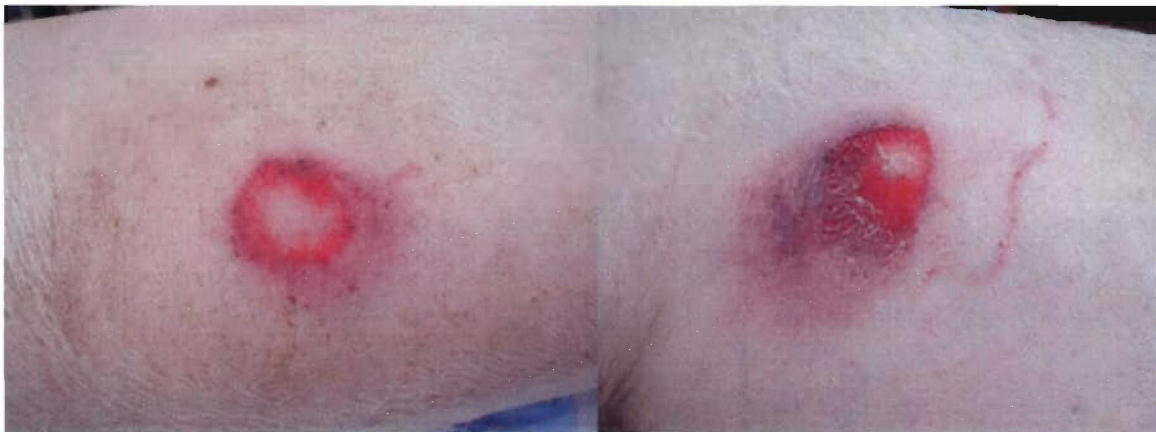
The injuries sustained by the subjects in the animal study compared well, and exhibited similar tendencies, when contrasted against the injury patterns in other experiments. The impacts from the animal study caused bruising and skin lesions to immediately form following the intervention. As time progressed, ecchymotic areas began forming in a similar manner to that observed in the NATO and the Magnan and Sarron studies (see Figure 13 below).

**Figure 13. Comparison of skin lesion formation and ecchymoses with NATO study**
